CARR-1239

Carpenter Shop

Springfield Hospital Center

Maryland Historical Trust State Historic Sites Inventory Form

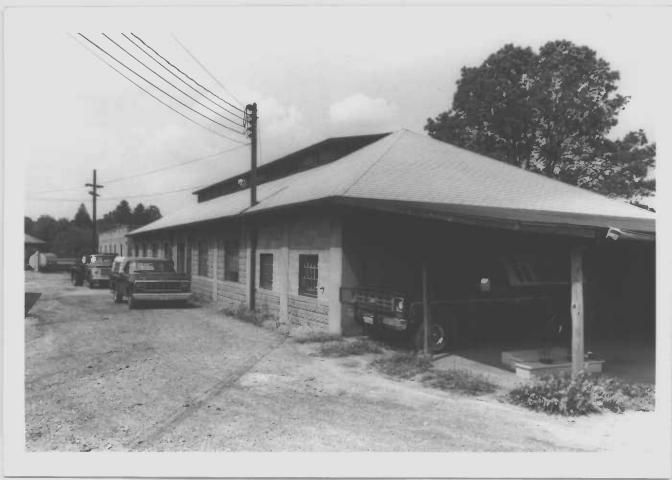
CARR-1239
Carpenter Shop
Springfield Hospital Center
Sykesville, Maryland
Don Jewell, 6/86
Negatives at MHT
West and South

The Carpenter Shop lies southeast of the powerhouse in the industrial group. The one story building is constructed of cement laid in a coursed pattern. The long, rectangular building measures nine bays long and three bays deep with a two bay long and three bay deep attachment on the south end. A composition, hipped roof covers the main portion of the building while the southern attachment shows a lean-to roof supported by unfinished wood posts. The entire structure rests on a cement foundation. The main facade looks west.

The central bay of the west face has been altered. Plywood laid in a diagonal direction covers the one bay area. The playwood surrounds the main entrance. The door is not original to the building. Sidelights flank the door. The southern most two bays of the east and west walls show a slightly different pattern. The cement bricks have smooth faces and the windows have a wooden sill and mullions. This portion of the building also exhibits a smooth cement slab just below the eave.

The attachment to the south wall is essentially an open area shielded by a lean-to roof. The south wall is visible under the lean-to roof area. The original double doors appear on the cement wall. The wooden doors exhibit an inverted cross pattern while a single row of header bricks form a vertical joint lintel. The original hardware is intact.
